Clear Creek Aquatic Habitat Assessment and Fish Distribution and Relative Abundance Surveys Sampling Framework

TECHNICAL MEMORANDUM • MAY 2015

Clear Creek Aquatic Habitat Condition Assessment and Fish Population Monitoring Field Sampling Protocol

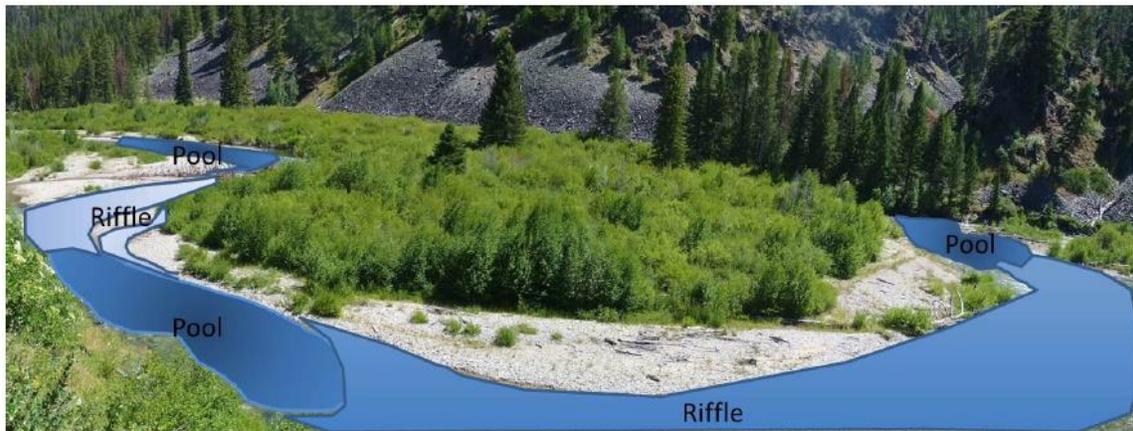
Figure 7. An example of habitat unit delineations (from CHaMP 2013).

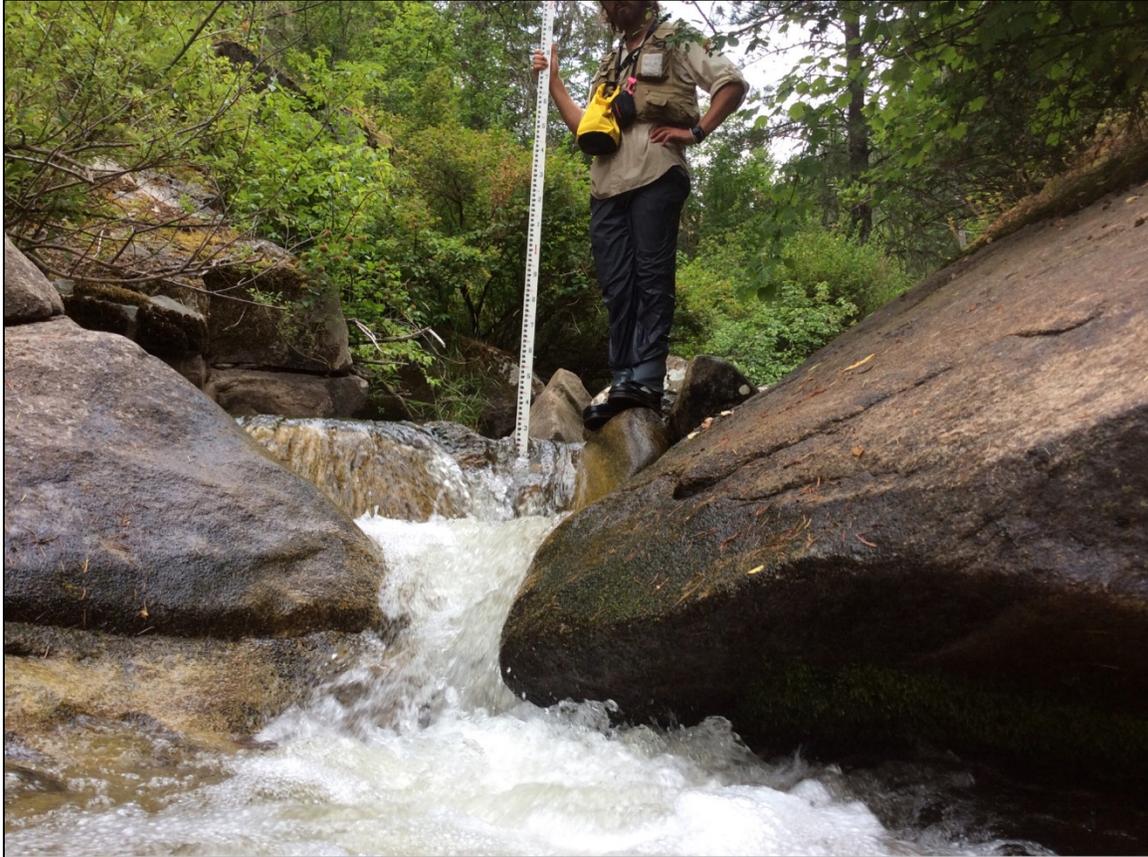
This feature may present a seasonal passage obstacle to anadromous salmonids during low flows due to jump distance required to pass and during high flows due to excessive velocities. However, a 0.9 m deep jump pool and the presence of a small, low-velocity depression for resting midway through is expected to facilitate passage at moderate stream flows. Presence of adult Chinook upstream indicate this feature is at most a low-flow passage obstacle.

Photo E-1. Looking upstream at Potential Barrier 6.1, located in Reach 6 of Clear Creek.

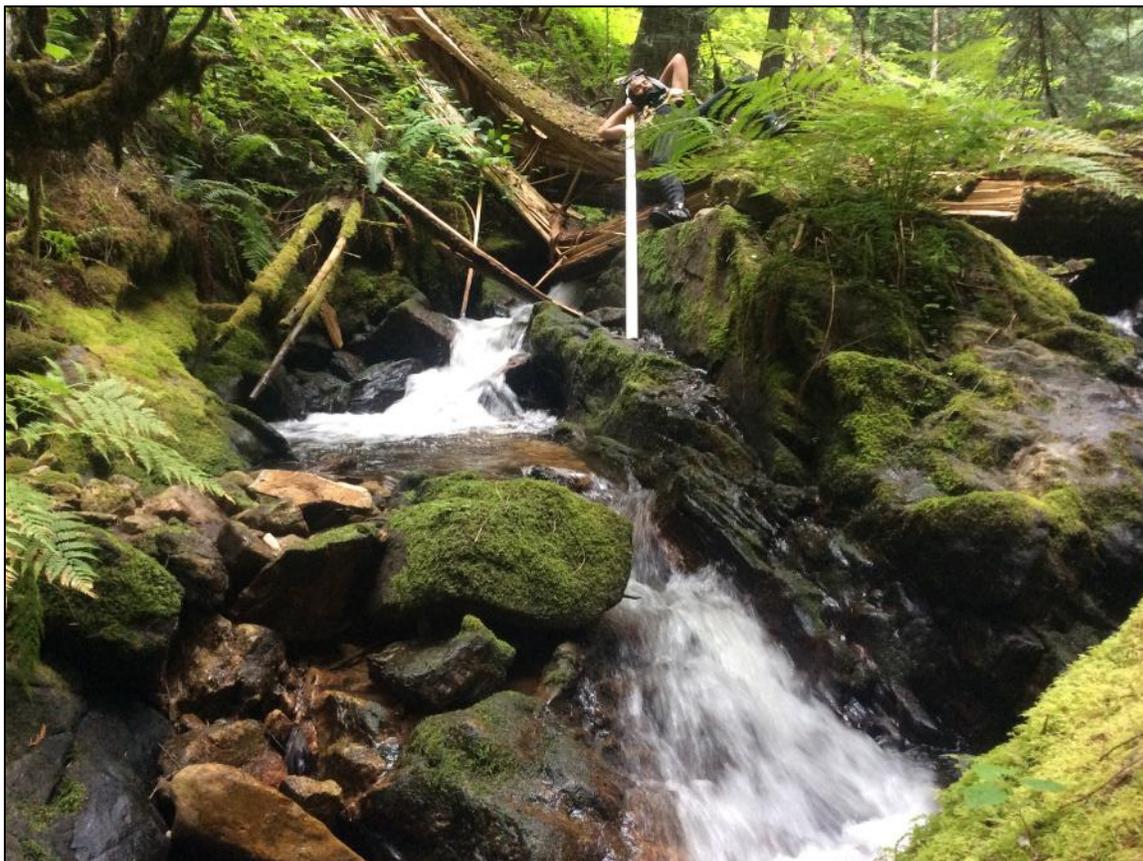
This feature consists of two, steep bedrock chutes with shallow, high velocity water and minimal jump pools downstream. At low flows, this site appears to present a total barrier to anadromous fish migration. At higher flows, there is a possible alternative passage route on river left, but water velocities may be too high for passage. This feature marks the documented upstream extent of *O.mykiss* in the mainstem of Clear Creek from 2015 snorkel surveys. Densities of cutthroat trout become much higher upstream of this location.

Photo E-2. Looking upstream at Potential Barrier 35.1, located in Reach 35 of Clear Creek.

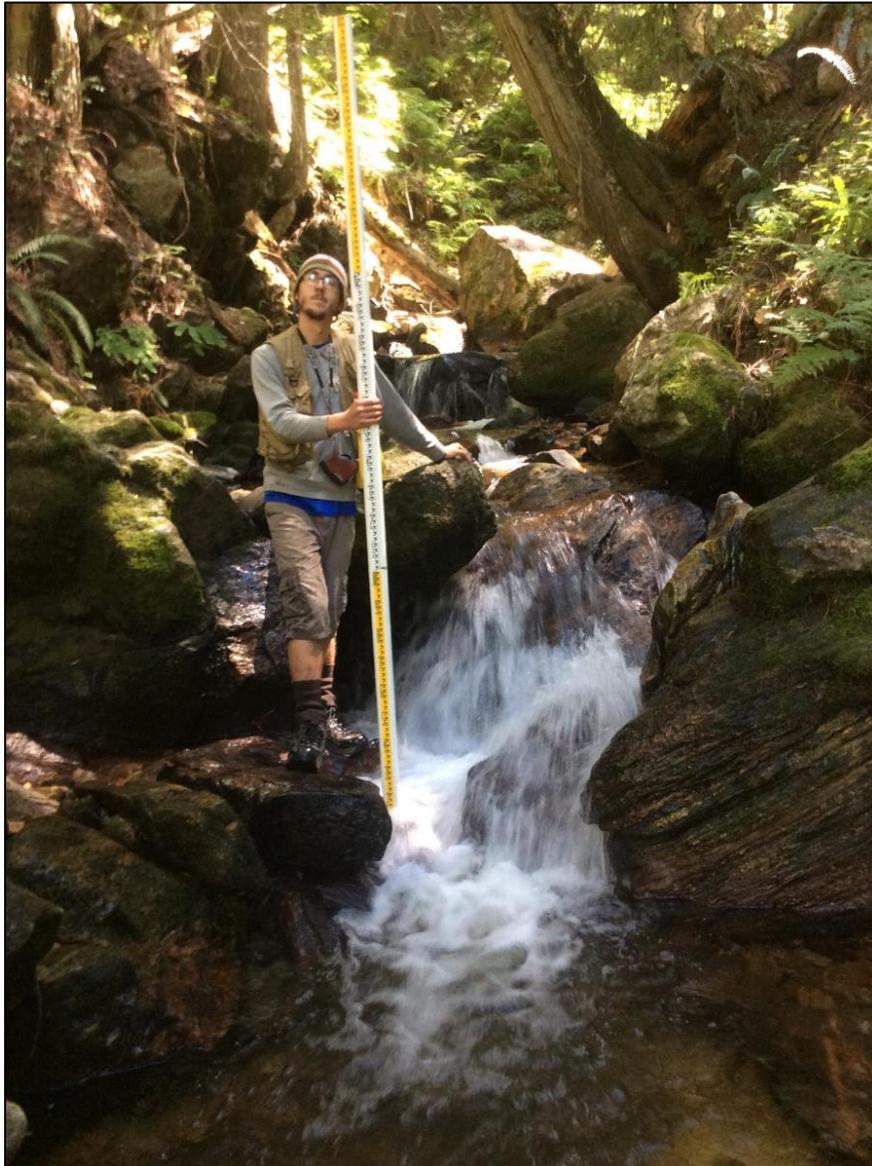
This is the first of three potential barriers within a 50 m high-gradient section of Clear Creek. The site, a 7 m long, steep bedrock/boulder cascade has multiple features that could impeded fish passage. On the downstream end, water sheets over a steep bedrock drop, which is expected to prevent fish passage at lower stream flows, but may be passable at moderate stream flows as water depth increases. On the upstream end there is a nearly 1 m high vertical drop that could also prevent passage at low flows due to the shallow jump pool. The site may be passable at moderate flows, but due to the constricted nature of the channel at this location, high water velocities at higher stream flows likely prevent fish passage.

Photo E-3. Looking upstream at Potential Barrier 36.1, located in Reach 36 of Clear Creek.

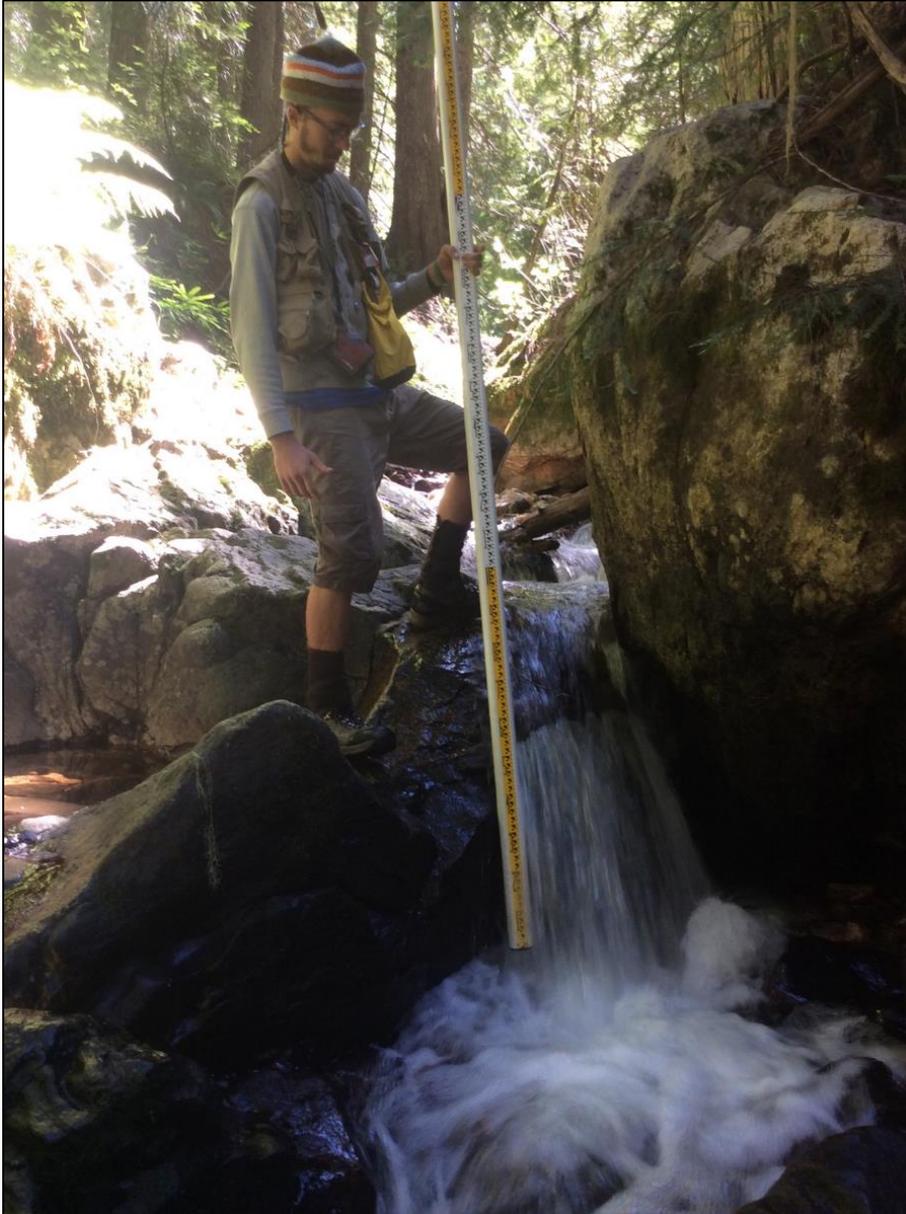
This is the second of three potential barriers within a 50 m high-gradient section of stream. This feature is within a short cascade and consists of a vertical drop onto boulders. Due to the drop and lack of a jump pool this feature is expected to be a barrier to fish passage at low stream flows. It may be passable at moderate flows via an intermediate jump pool on the right bank, but water velocities may deter fish passage at higher stream flows due to the highly confined and high gradient nature of the channel.

Photo E-4. Looking upstream at Potential Barrier 36.2, located in Reach 36 of Clear Creek.

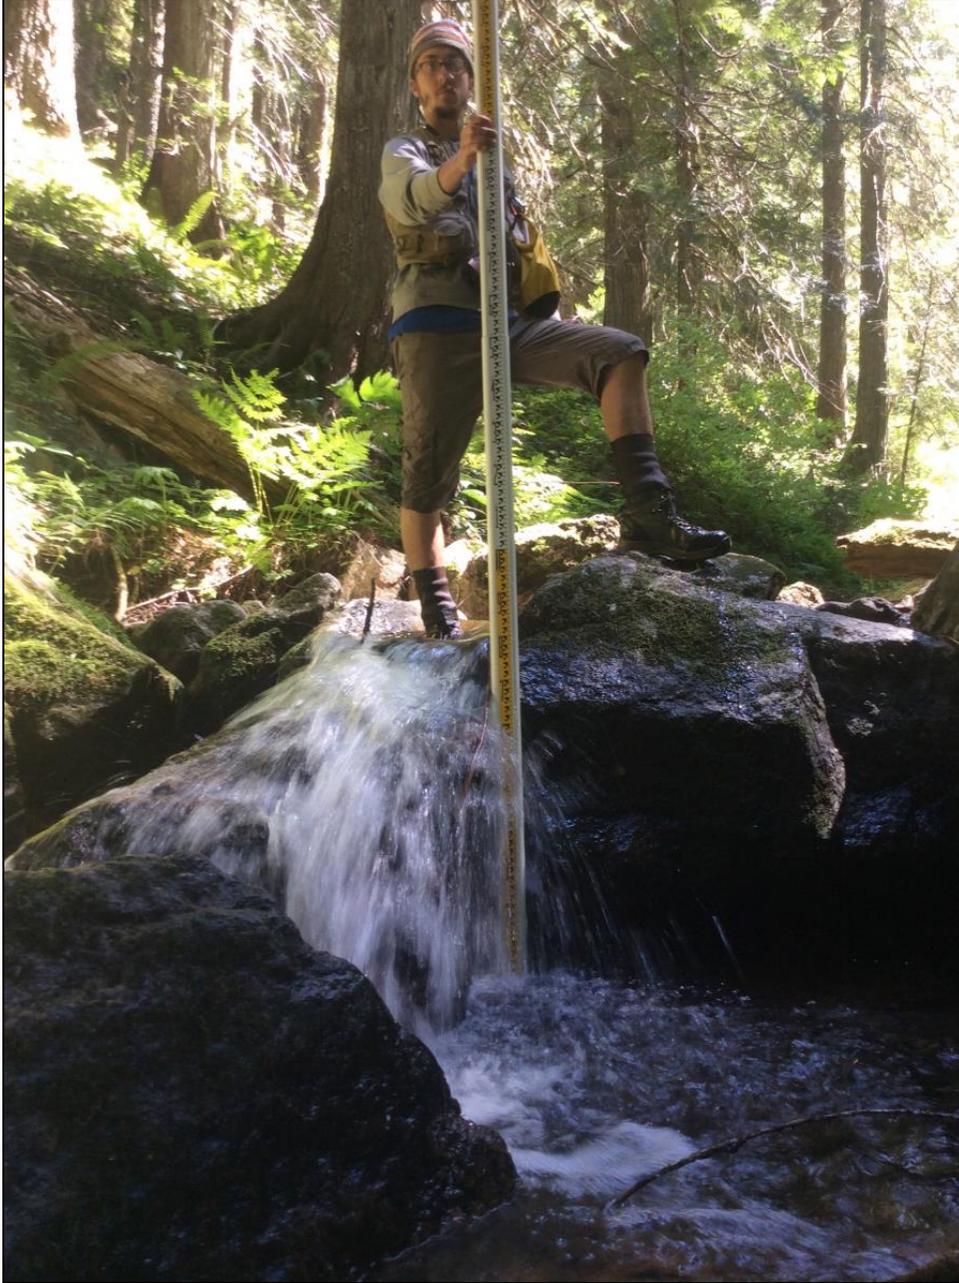
This is the third of three barriers within a 50 m high-gradient section of stream. This feature may present a seasonal, low-flow barrier due to the orientation of the jump pool in relation to the jump. However, it is expected to be passable at moderate to high stream flows.

Photo E-5. Looking upstream at Potential Barrier 36.3, located in Reach 36 of Clear Creek.

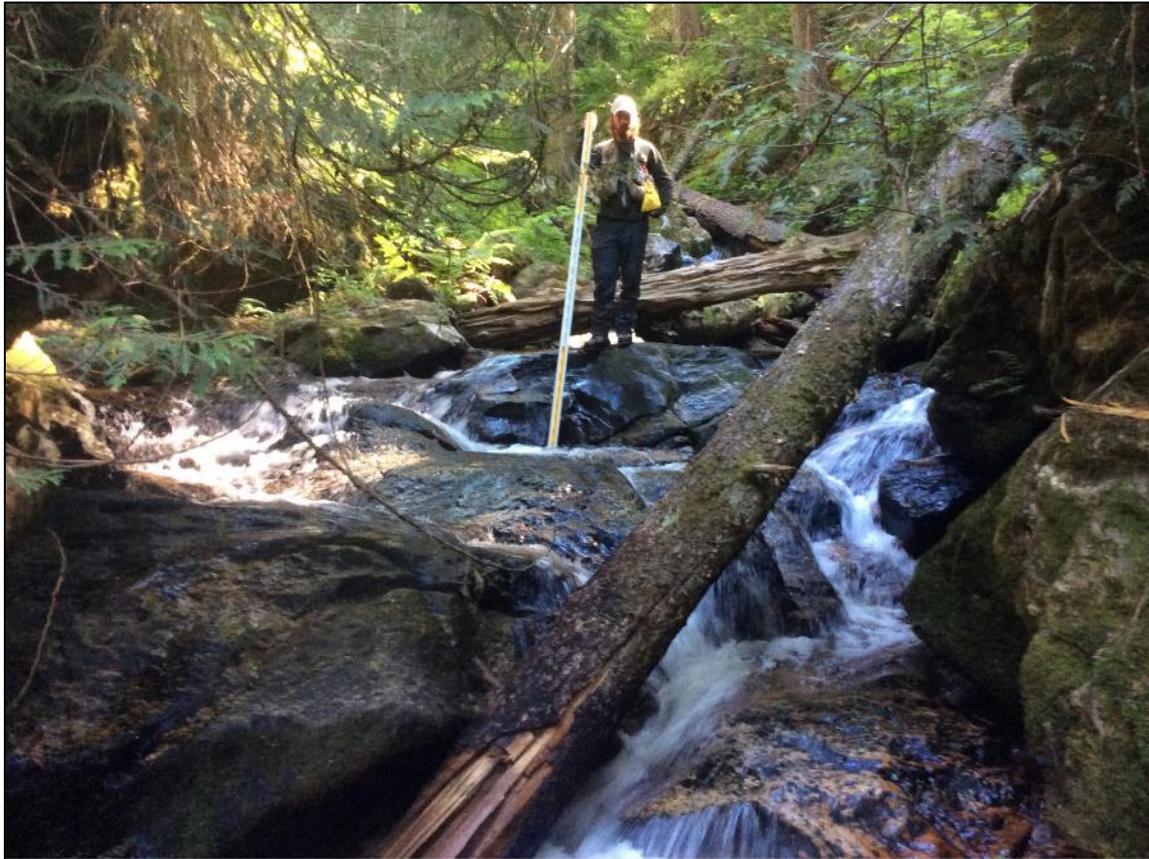
This is the first of three potential barriers within a 75 m high-gradient section of stream and the fourth in Reach 36. The feature is a 7 m long cascade with an overall gradient of 18%. It consists of several high-gradient channels and steep drops cutting across bedrock. Standard measurements were not recorded due to complexity of the site. Small depressions that could be used for holding occur throughout the feature, and therefore fish passage may be possible for some fish at moderate stream flows when ample depth is available to traverse the bedrock. However, this site in combination with similar features just upstream, is likely a considerable obstacle to fish passage and may constitute as a total barrier.

Photo E-6. Looking upstream at Potential Barrier 36.4, located in Reach 36 of Clear Creek.

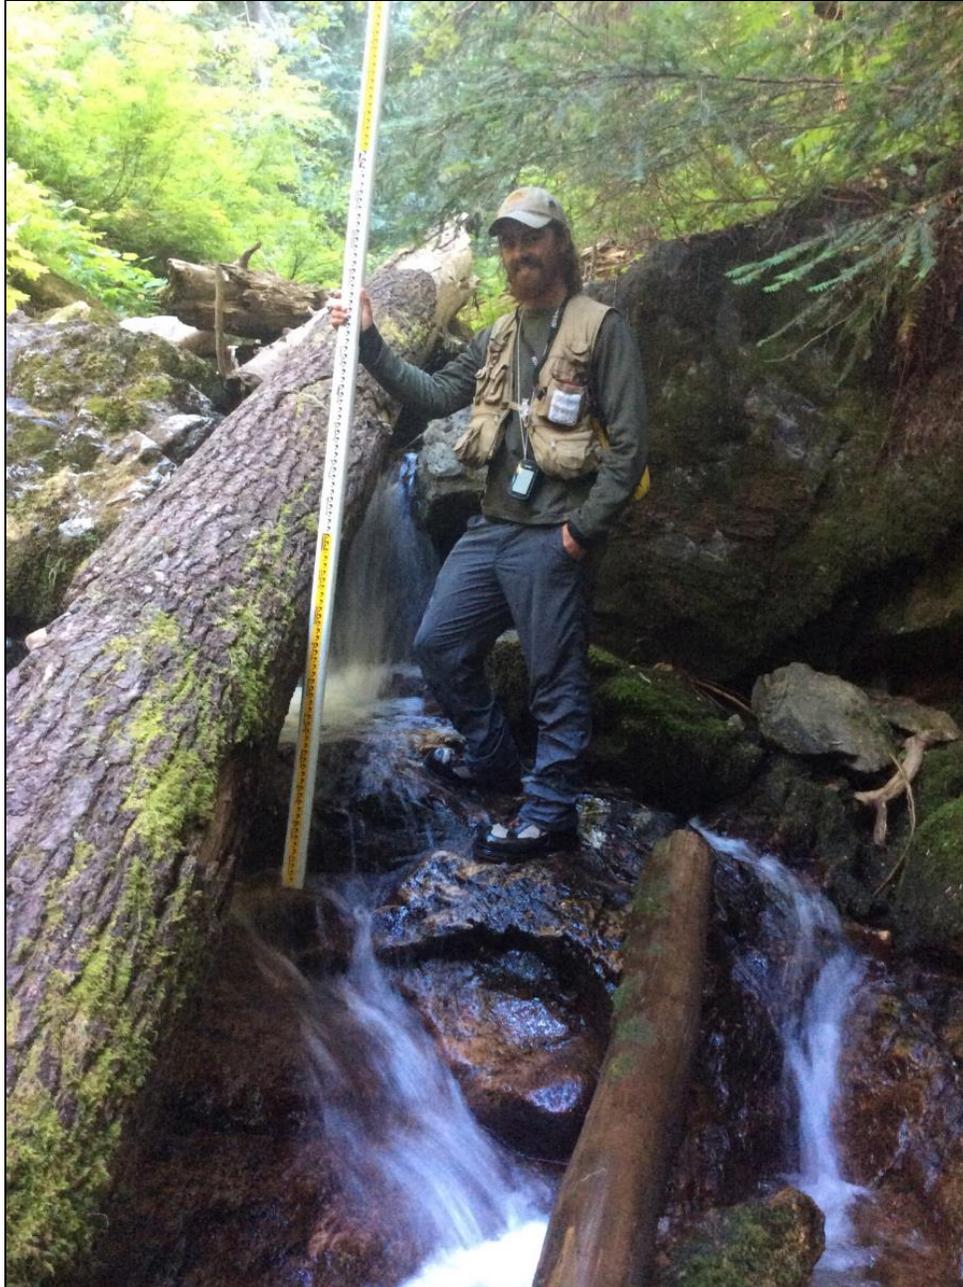
This is the second of three potential barriers within a 75 m long high-gradient section of stream and the fifth in Reach 35. This feature is an 11 m long falls/cascade consisting of two separate of vertical drops exceeding 1 m, along with water sheeting over bedrock and boulders. Fish passage is expected to be very challenging if not impossible across most stream flows. At low flows water depth and lack of jump pools limit passage. At moderate and high flows water velocities are expected to be too high for passage. In combination with considerable obstacles just downstream and upstream, this site is expected to be a barrier to both resident and anadromous fish.

Photo E-7. Looking upstream at Potential Barrier 36.5, located in Reach 36 of Clear Creek.

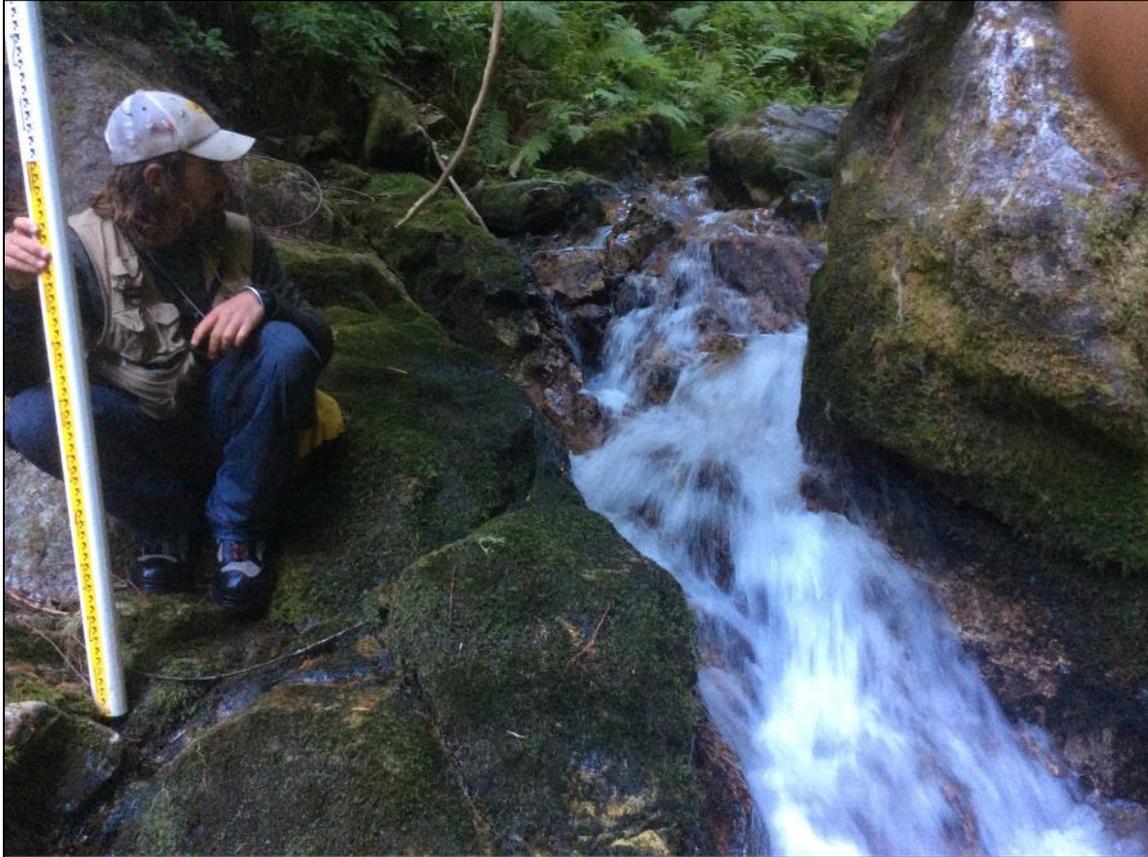
This is the third of three potential barriers within a 75 m high-gradient section of stream and the sixth in Reach 36. This feature is a 9 m long, steep bedrock chute that presents a potential barrier due to shallow depths and lack of resting pools at low flows and high water velocities at higher flows. This sites is expected to present a major obstacle to fish passage, if not a total barrier, under most conditions.

Photo E-8. Looking upstream at Potential Barrier 36.6, located in Reach 36 of Clear Creek.

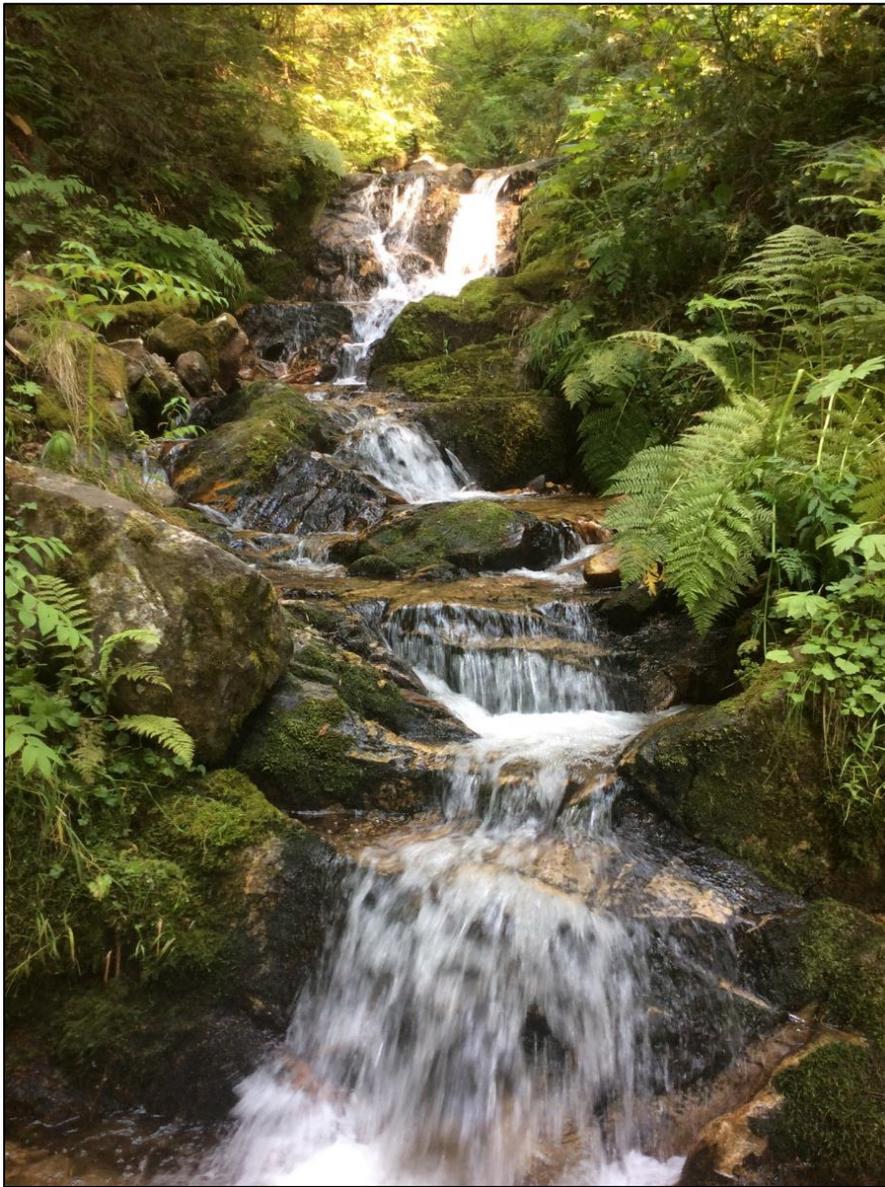
This site is the first of two likely barriers within a 25 m high-gradient section of stream just upstream from the confluence with mainstem Clear Creek. This site is an 11 m long, steep bedrock cascade with a nearly vertical high waterfall at the top that is > 2 m high and lacks a jump pool. The feature also contains several other shorter vertical drops. Based on the combination of physical drops and high water velocities as well as a significant waterfall just upstream, this site is expected to be a total barrier to fish movement. No cutthroat trout were found upstream of this feature.

Photo E-9. Looking upstream at Potential Barrier 49.1, located in Reach 49 in a small tributary to Clear Creek known as "Tailed Frog Creek".

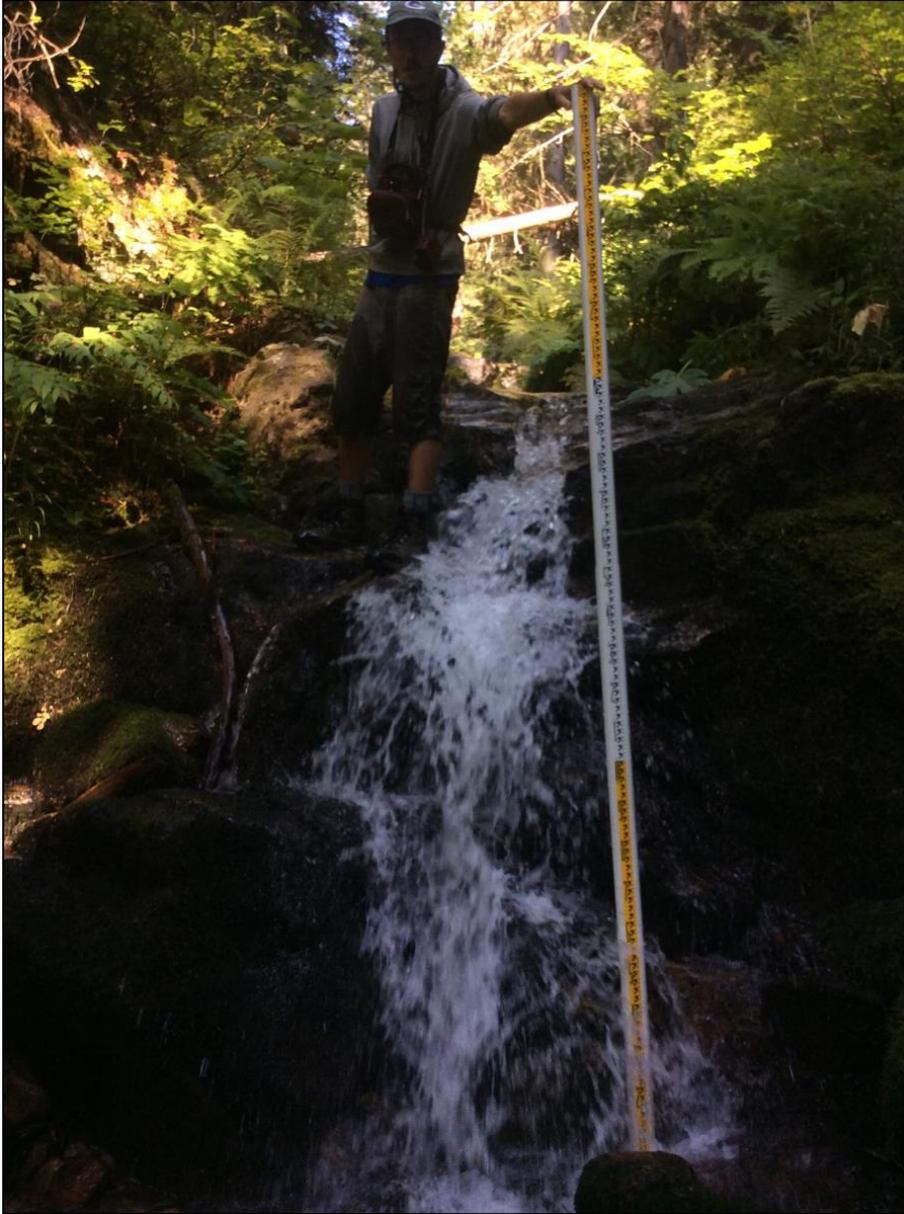
This site is the second of two likely barriers within a 25 m high-gradient section of stream just upstream of the confluence with mainstem Clear Creek. This site consists of a 4.7 m steep bedrock cascade/falls with a 2.4 m vertical drop at the top. It is expected that this site, along with a similar feature just downstream, constitutes a total barrier to fish passage. This site is upstream of the documented upper distributions of anadromous salmonids and cutthroat trout.

Photo E-10. Looking upstream at Potential Barrier 49.2, located in Reach 49 in a small tributary to Clear Creek known as “Tailed Frog Creek”.

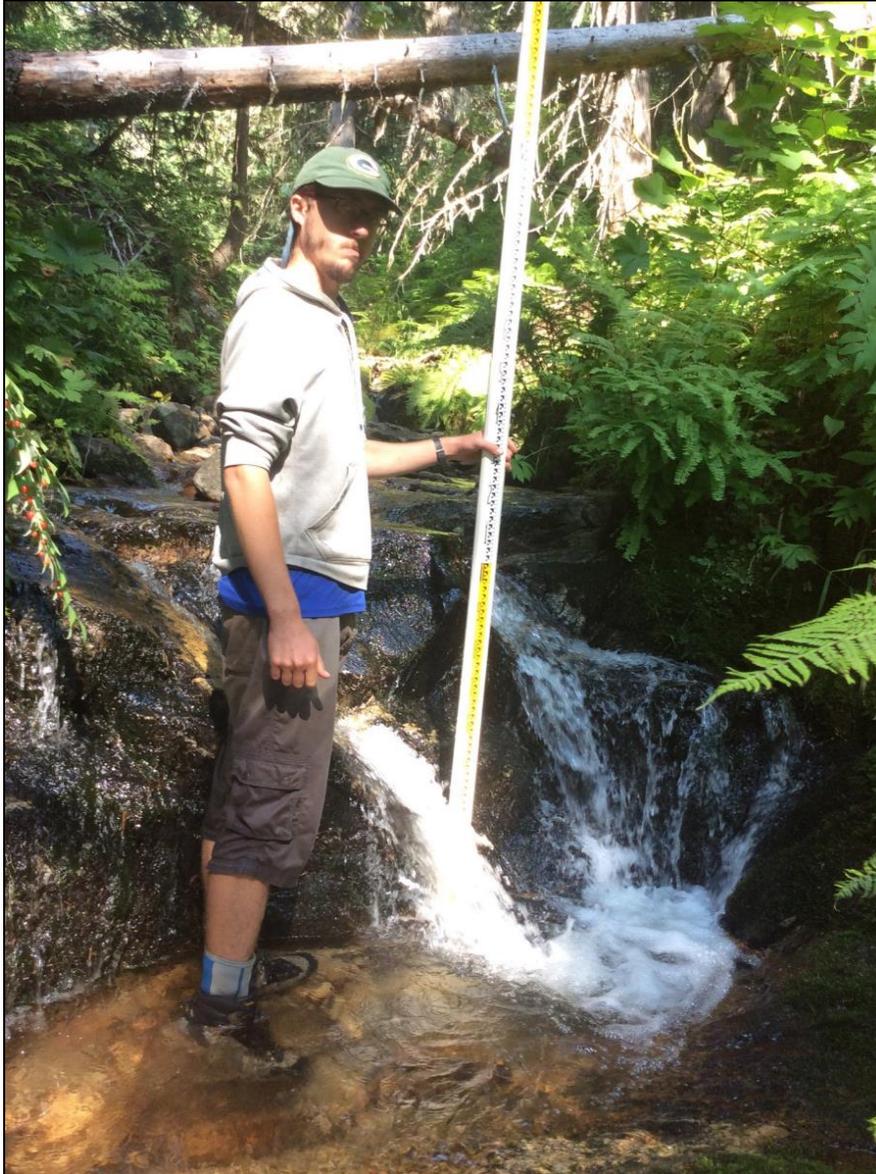
This site, a short cascade may present a seasonal, low-flow obstacle to fish passage due to a small and relatively shallow jump pool, a shallow crest, and lack of upstream resting areas. However, this site is likely passable by fish at moderate stream flows. This site is upstream of two likely total barriers and above the documented upper distribution of cutthroat trout.

Photo E-11. Looking upstream at Potential Barrier 49.3, located in Reach 49 in a small tributary to Clear Creek known as "Tailed Frog Creek".

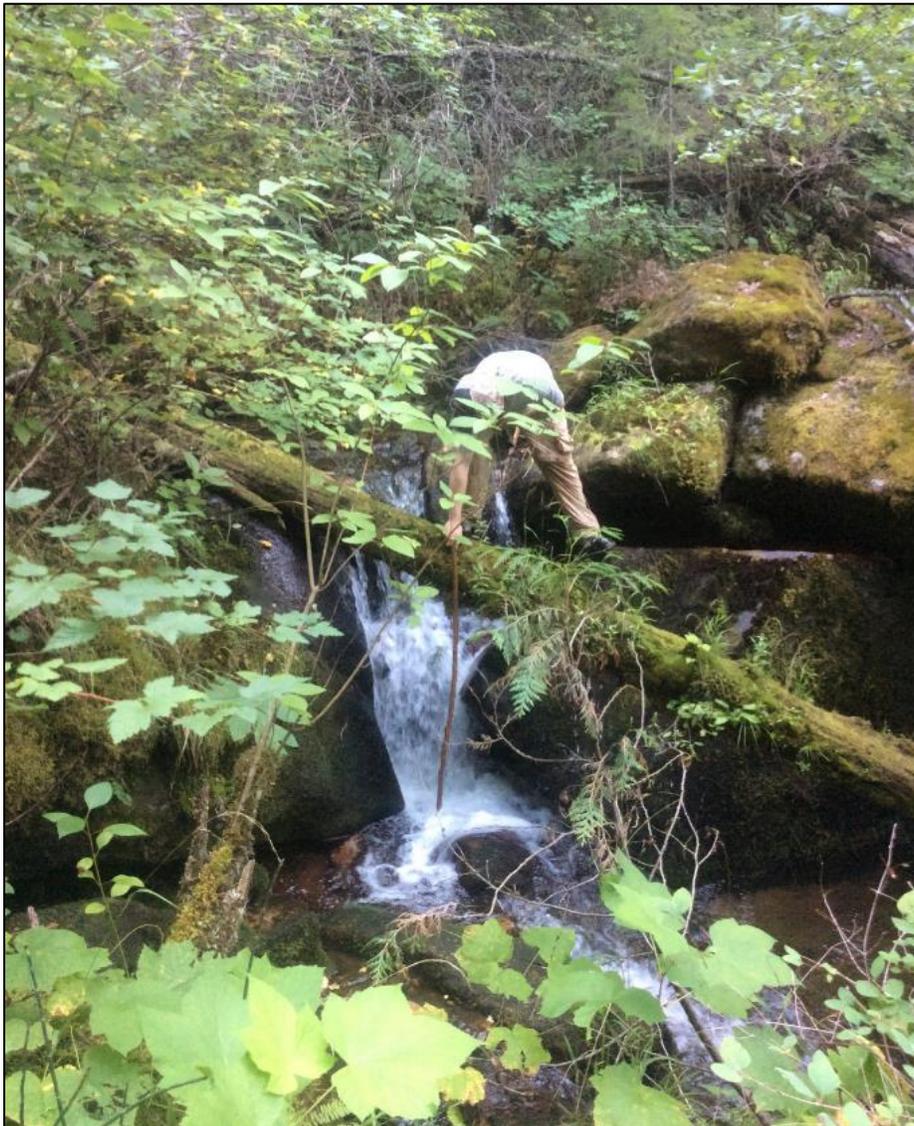
Photo E-12. Looking upstream at Potential Barrier 12.1, located in Reach 12 of West Fork Clear Creek.

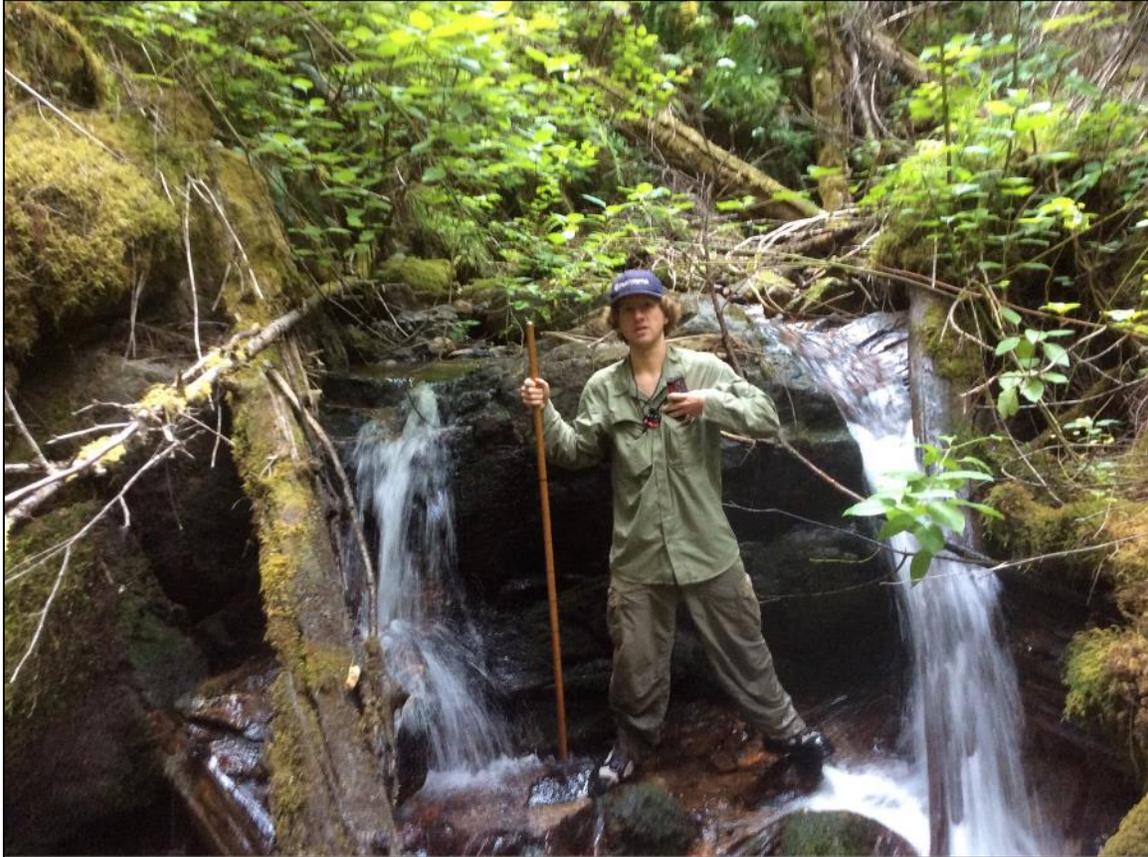
Photo E-13. Looking upstream at Potential Barrier 25.1, located in Reach 25 of West Fork Clear Creek.

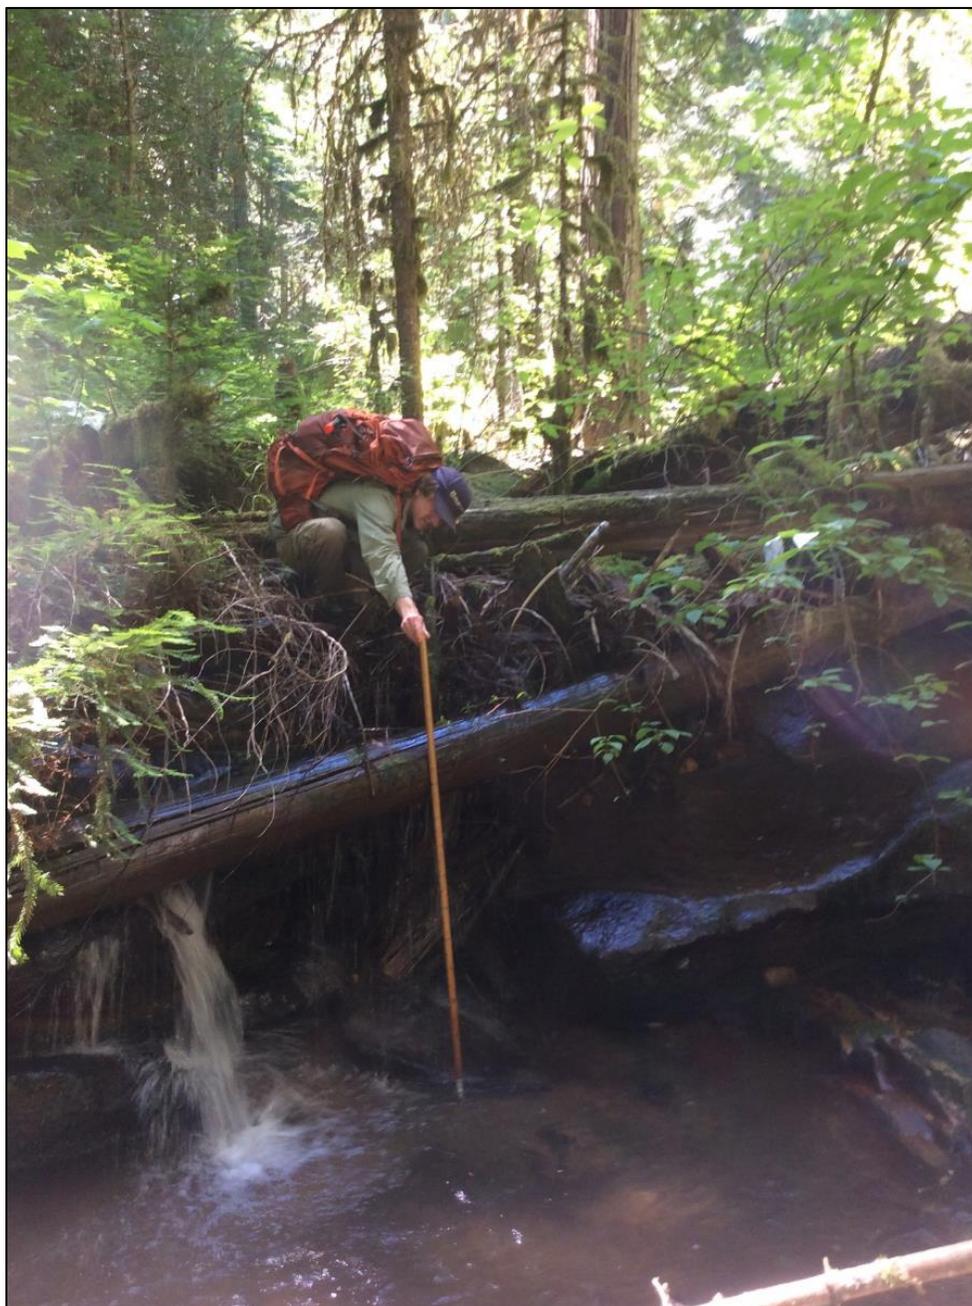
Photo E-14. Looking upstream at Potential Barrier 27.1, located in Reach 27 of West Fork Clear Creek.

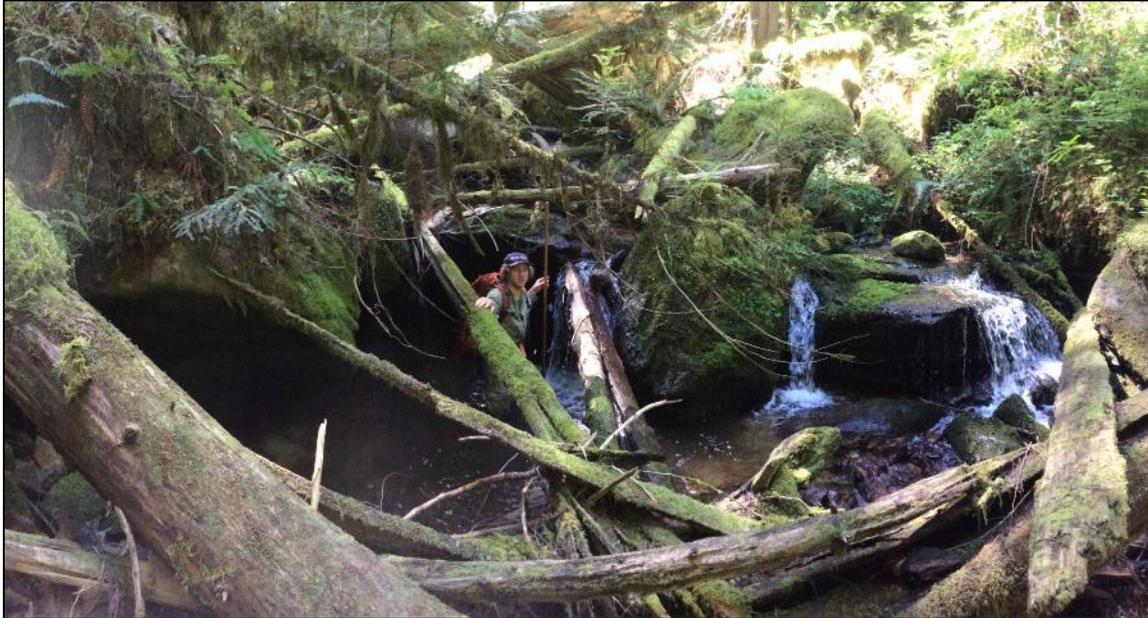
Photo E-15. Looking upstream at Potential Barrier 27.2, located in Reach 27 of West Fork Clear Creek.

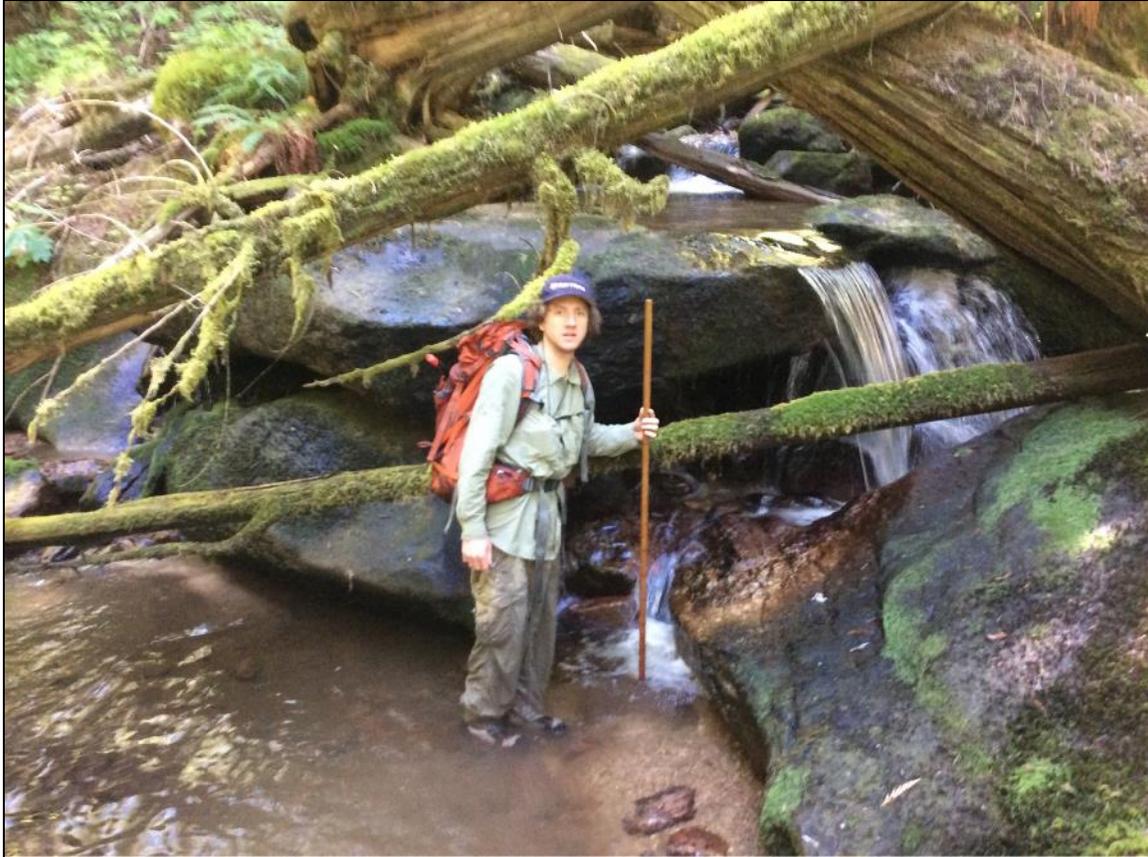
Photo E-16. Looking upstream at Potential Barrier 27.3, located in Reach 27 of West Fork Clear Creek.

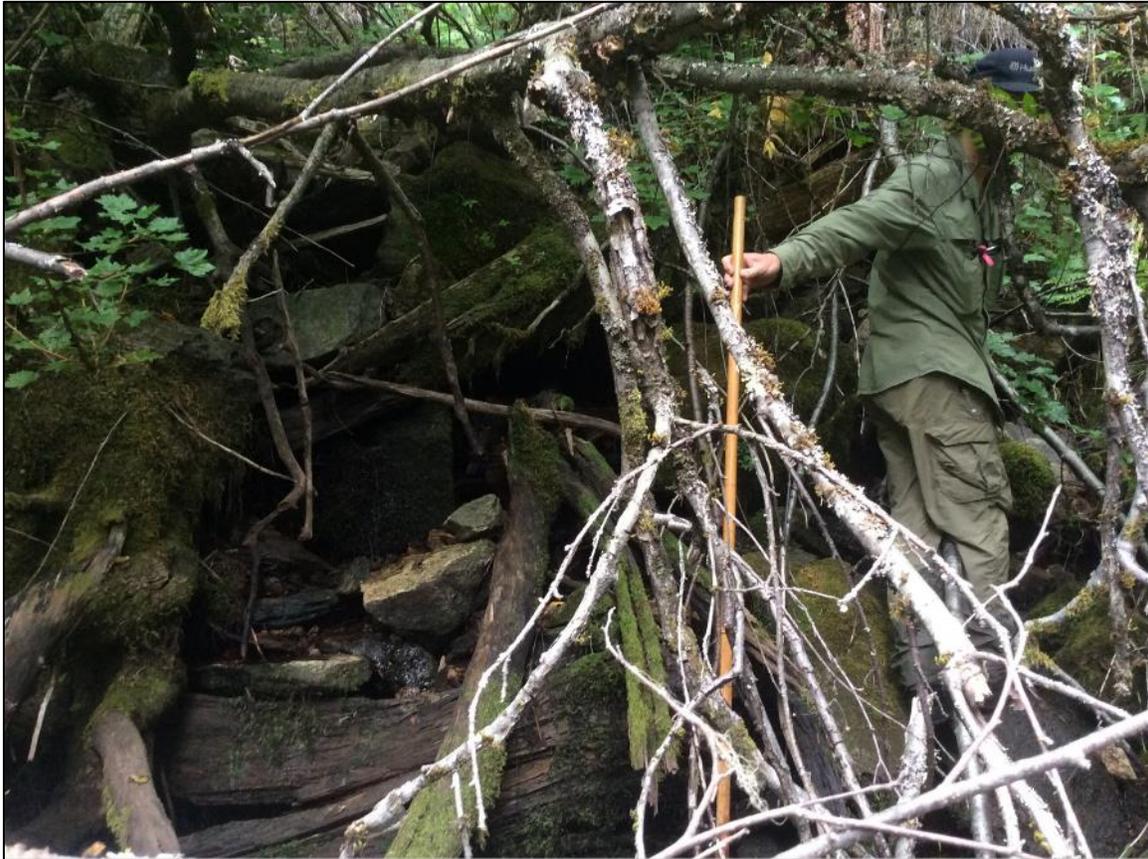
Photo E-17. Looking upstream at Potential Barrier 29.1, located in Reach 29 of Lost Mule Creek, a small tributary to West Fork Clear Creek.

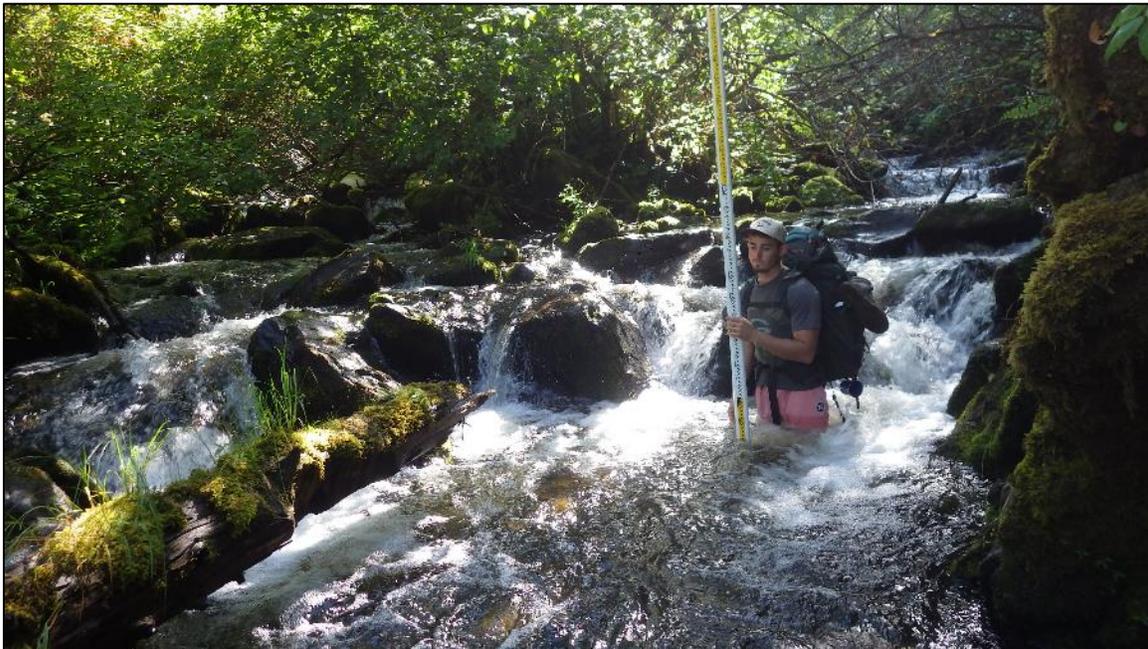
Photo E-18. Looking upstream at Potential Barrier 15.1, located in Reach 15 of South Fork Clear Creek.

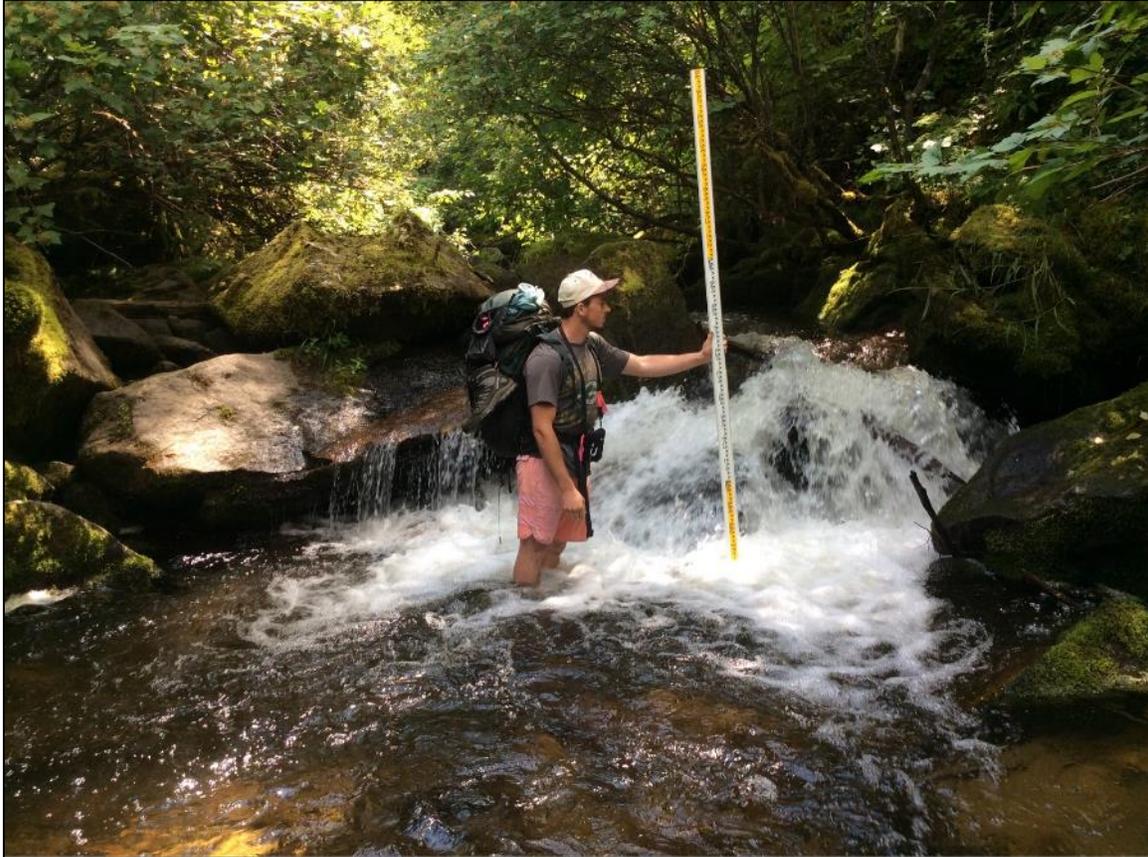
Photo E-19. Looking upstream at Potential Barrier 15.2, located in Reach 15 of South Fork Clear Creek.

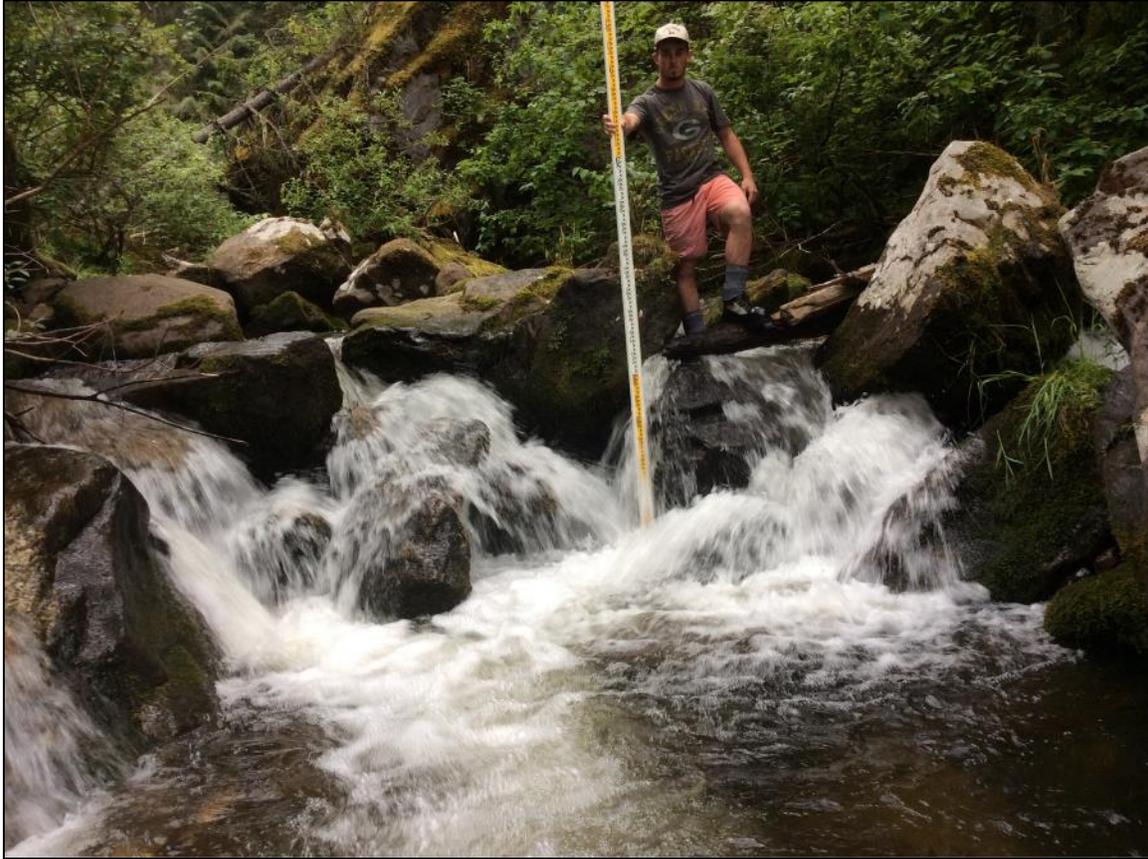
Photo E-20. Looking upstream at Potential Barrier 15.3, located in Reach 15 of South Fork Clear Creek.
