Clear Creek Aquatic Habitat Assessment and Fish Distribution and Relative Abundance Surveys Sampling Framework

TECHNICAL MEMORANDUM • MAY 2015

Clear Creek Aquatic Habitat Condition Assessment and Fish Population Monitoring Field Sampling Protocol

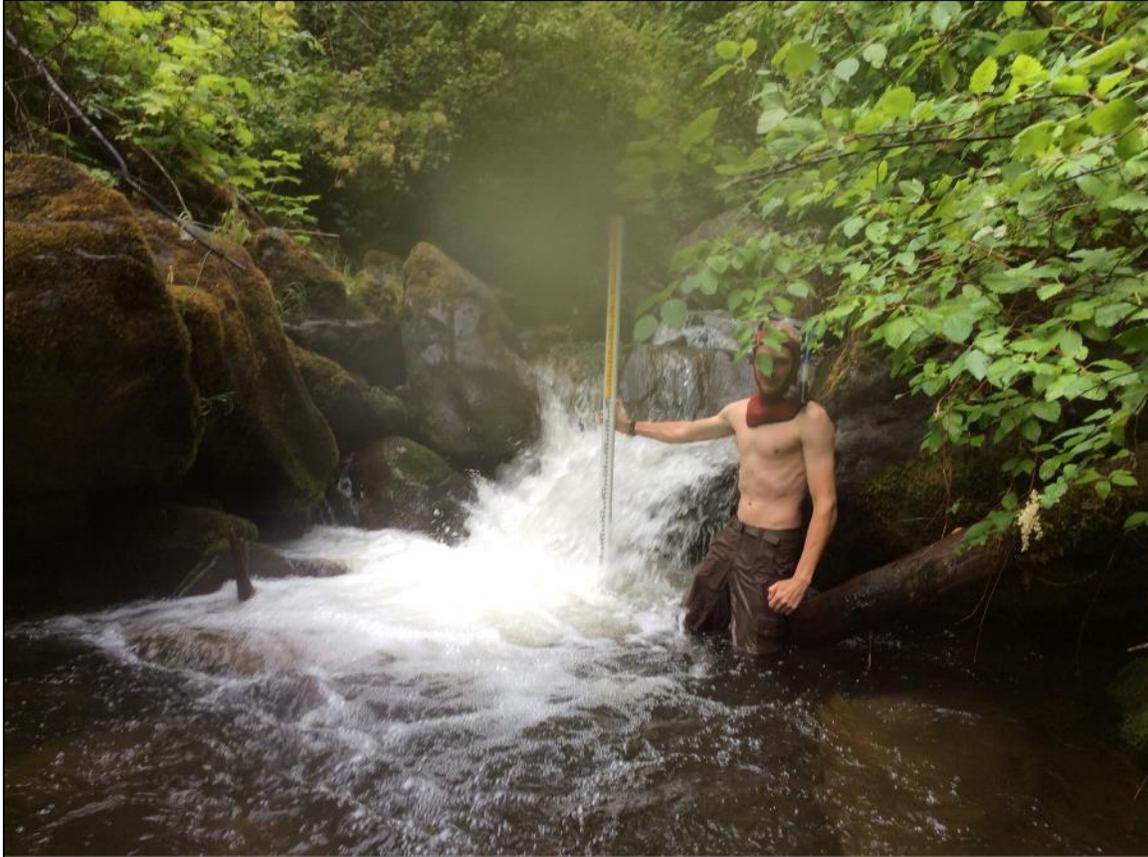
Photo E-21. Looking upstream at Potential Barrier 15.4, located in Reach 15 of South Fork Clear Creek.

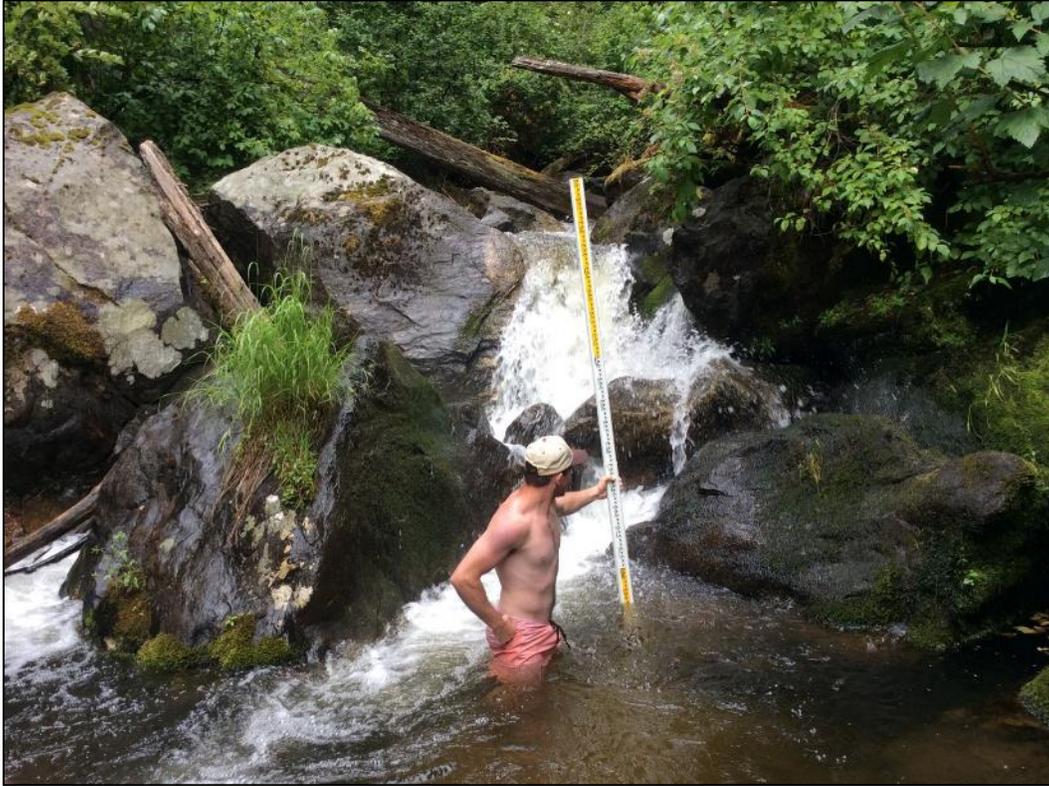
Photo E-22. Looking upstream at Potential Barrier 15.5, located in Reach 15 of South Fork Clear Creek.

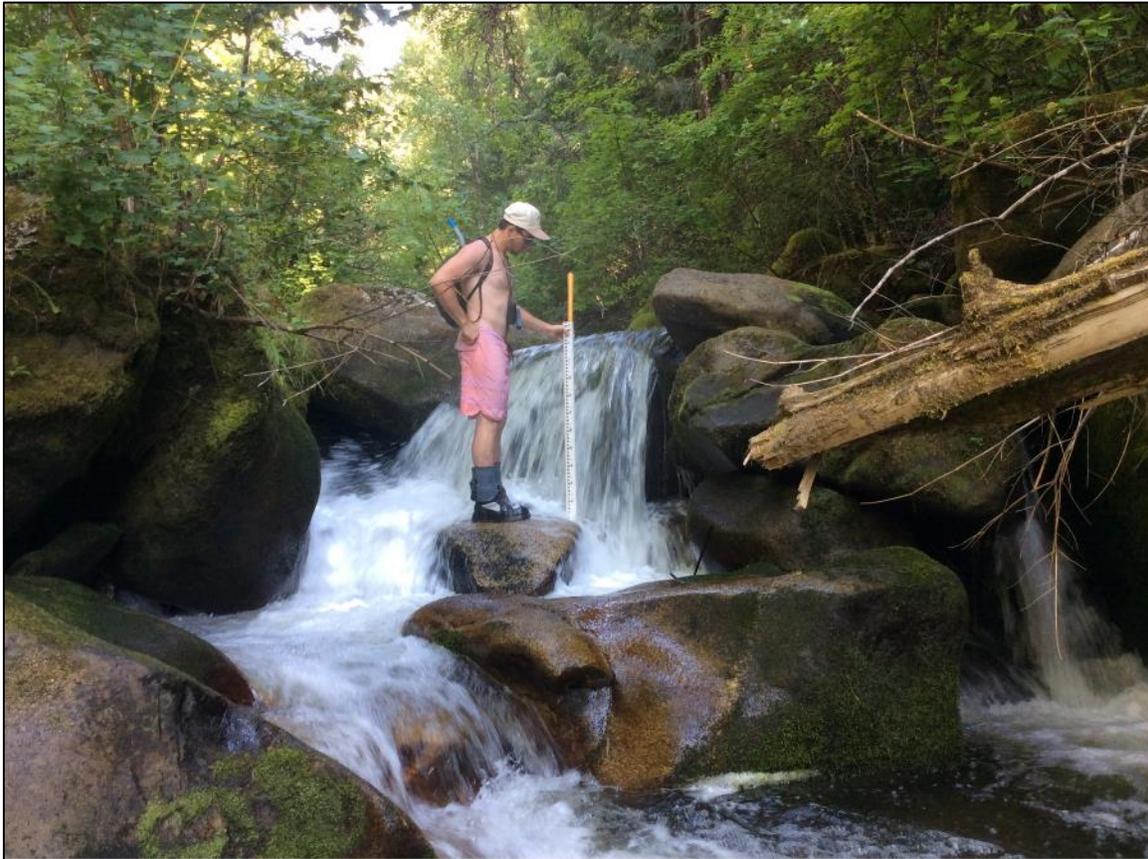
Photo E-23. Looking upstream at Potential Barrier 17.1, located in Reach 17 of South Fork Clear Creek.

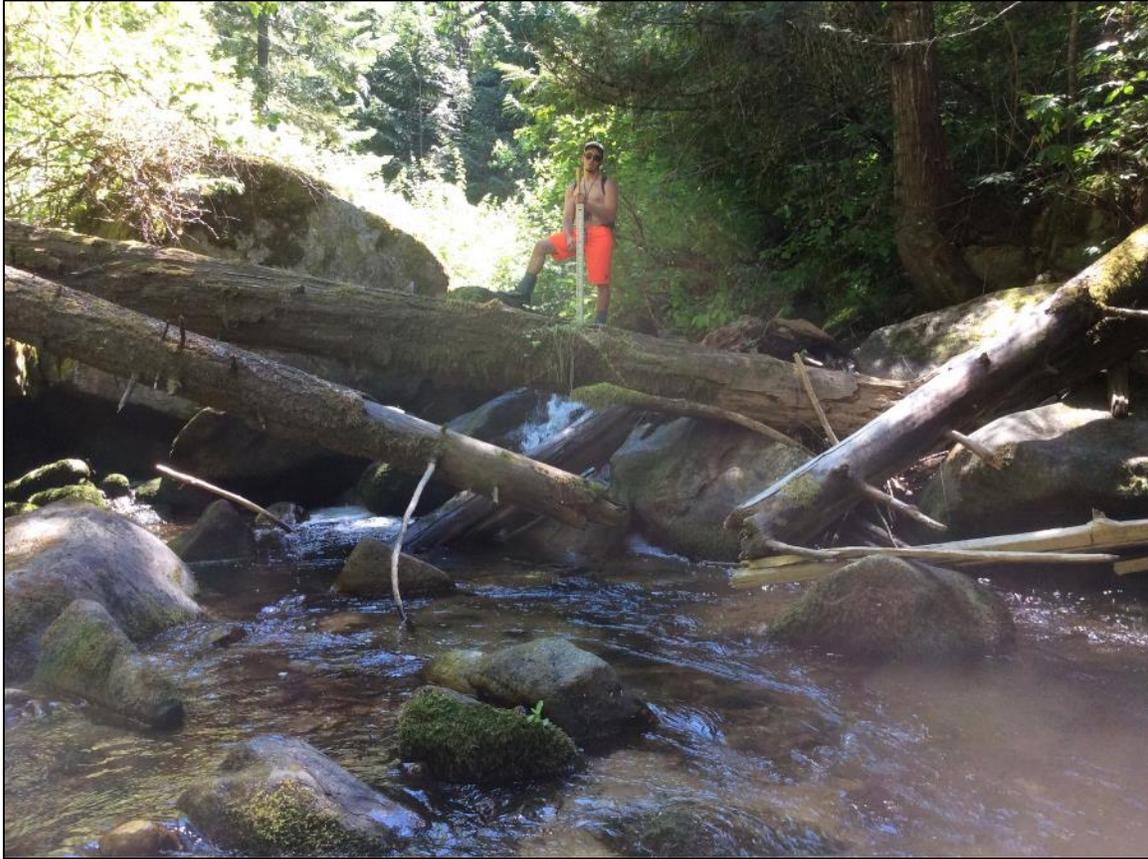
Photo E-24. Looking upstream at Potential Barrier 19.1, located in Reach 19 of South Fork Clear Creek.

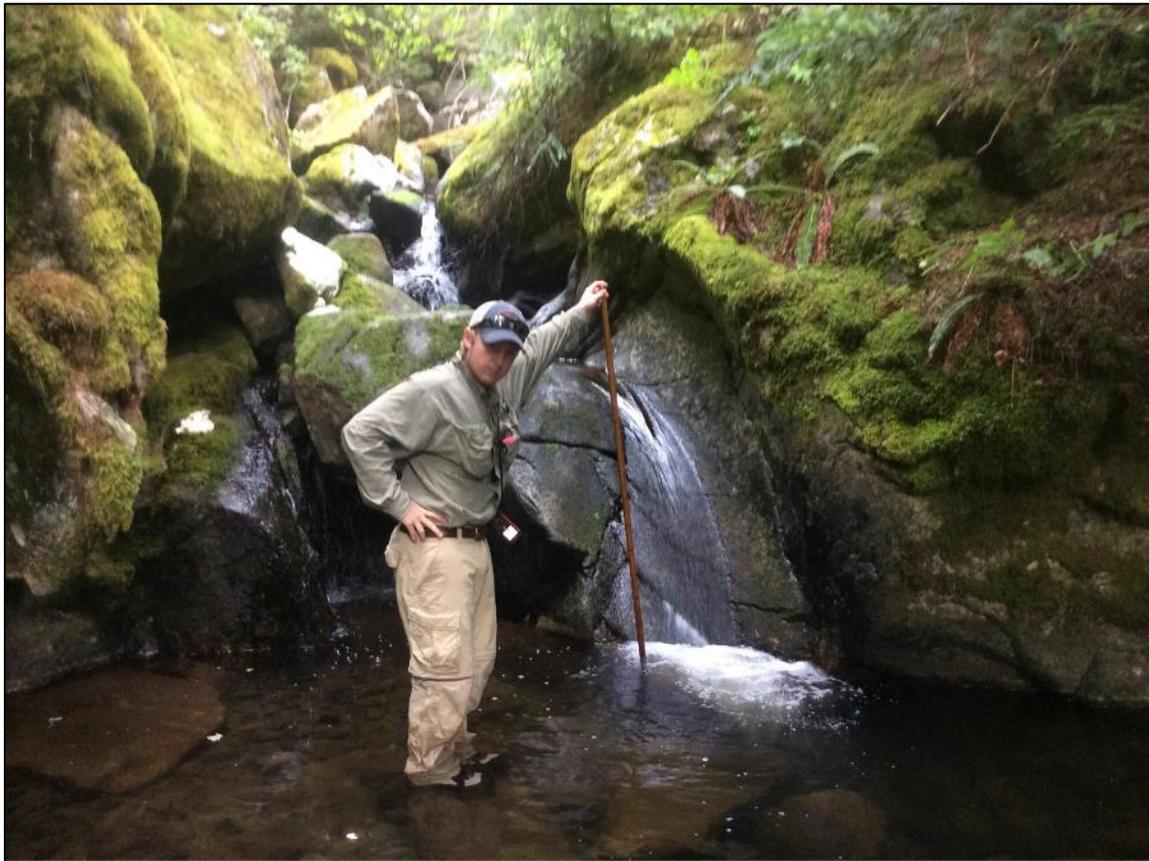
Photo E-25. Looking upstream at Potential Barrier 48.1, located in Reach 48 of Pine Knob Creek.

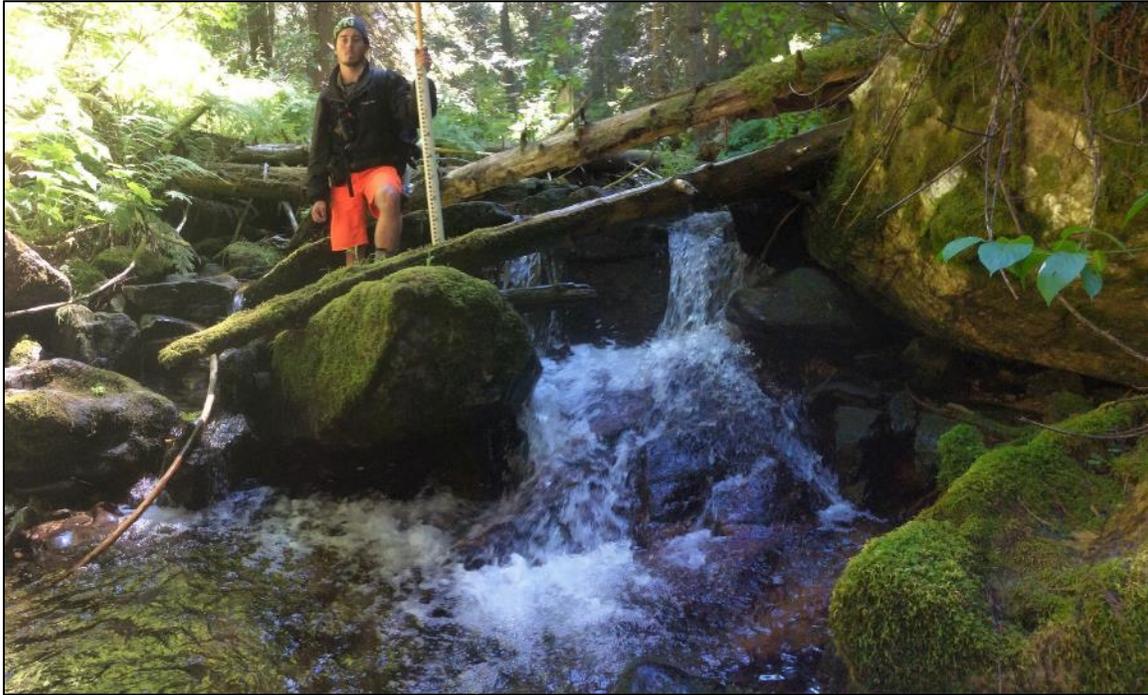
Photo E-26. Looking upstream at Potential Barrier 42.1, located in Reach 42 of Browns Spring Creek.

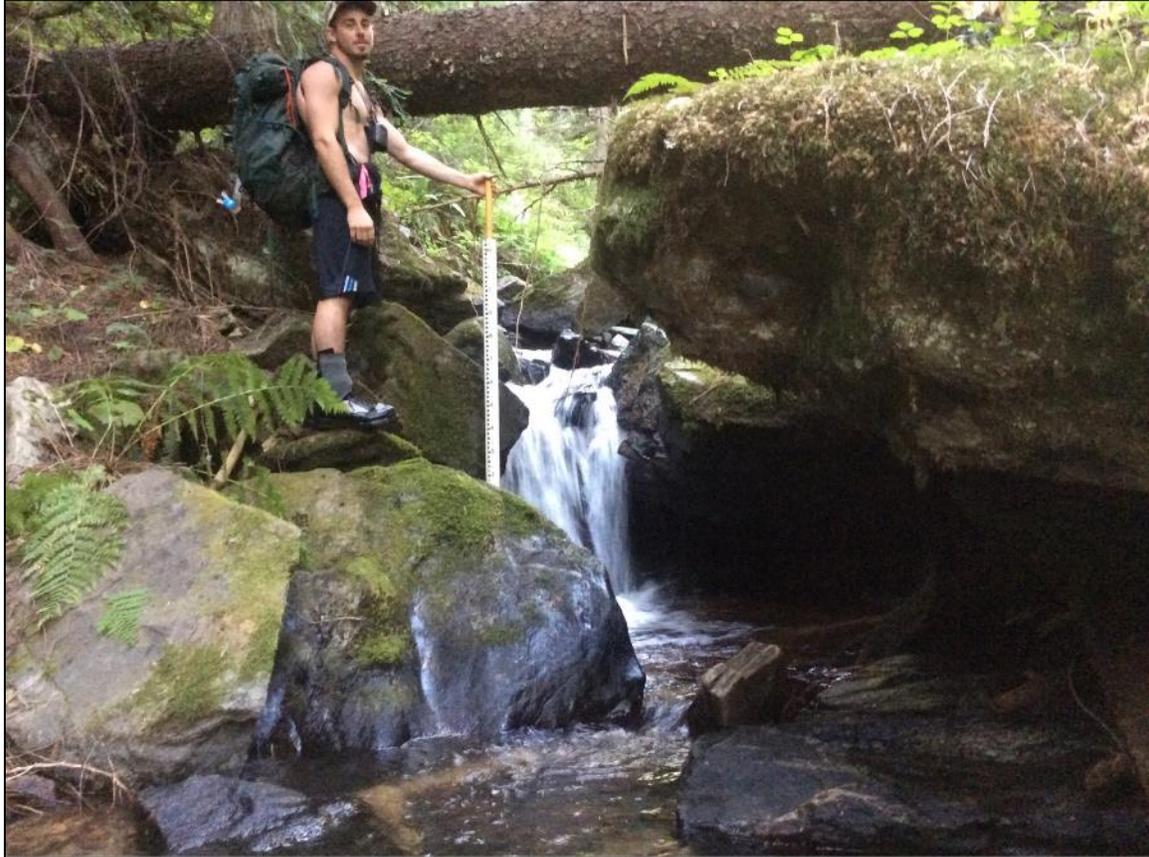
Photo E-27. Looking upstream at Potential Barrier 44.1, located in Reach 44 of Browns Spring Creek.
